**Flood Control Project Maintenance
Levee Inspections**

Maintenance Issue Types Only, Levee Inspection Report By Mile - Spring 2019

Yolo County Service Area 6

Waterway	Bank	Unit Miles	Inspection Start/End	Inspector
Unit No. 01 Right Bank of Sacramento River at Knights Landing	Right	5.87	03/29/2019 03/29/2019	Zach Jojola

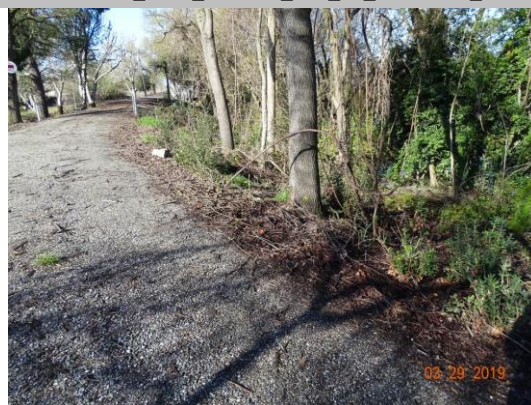
Photo 1 of 1 : SP_2019_NA0022_350_43_20190329_00128.jpg

LM Start	0.19	Rating **	M	Issue No.	43
LM End	0.19	Issue Type +	Ma	Location *	WS
Category	Earthen Levee			GPS Latitude/Longitude	
				Start	End
Item	Vegetation			38.801122 °	38.801122 °
				-121.722265 °	-121.722265 °
DWR ID	DWR_NA0022_01_s_2019_43				
Comment Code					
V2 : Remove the wild growth other than native grasses from the levee slopes.					
Inspector Comment

View of vegetation on the waterside slope. Spring 2019.

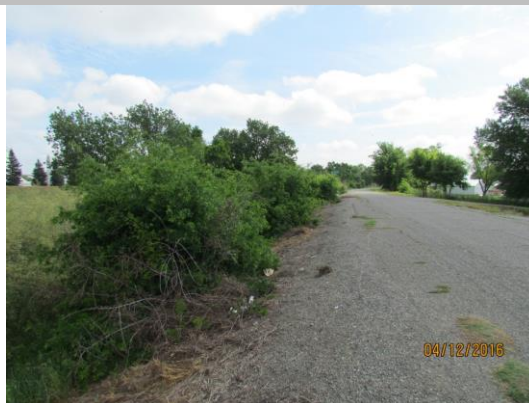
Photo 1 of 1 : SP_2019_NA0022_350_102_20190304_00050.jpg

LM Start	0.35	Rating **	M	Issue No.	102
LM End	0.48	Issue Type +	Ma	Location *	WS
Category	Earthen Levee			GPS Latitude/Longitude	
				Start	End
Item	Vegetation			38.801887 °	38.802225 °
				-121.719587 °	-121.717186 °
DWR ID	DWR_NA0022_01_s_2016_102				
Comment Code					
V2 : Remove the wild growth other than native grasses from the levee slopes.					
Inspector Comment					
Remove trees less than 4" in diameter at chest height.

View of the trees on the waterward side of the levee looking downstream. Spring 2016.

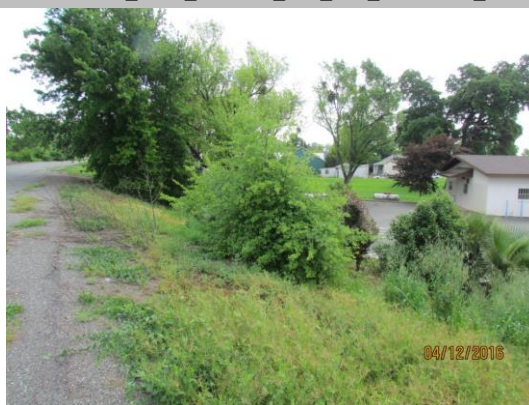
Photo 1 of 1 : SP_2019_NA0022_350_104_20190304_00051.jpg

LM Start	0.41	Rating **	M	Issue No.	104
LM End	0.43	Issue Type +	Ma	Location *	LS
Category	Earthen Levee			GPS Latitude/Longitude	
				Start	End
Item	Vegetation			38.802066 °	38.802126 °
				-121.718477 °	-121.718133 °
DWR ID	DWR_NA0022_01_s_2016_104				
Comment Code					
V2 : Remove the wild growth other than native grasses from the levee slopes.					
Inspector Comment

View of the tree on the landward side of the levee looking downstream. Spring 2016.

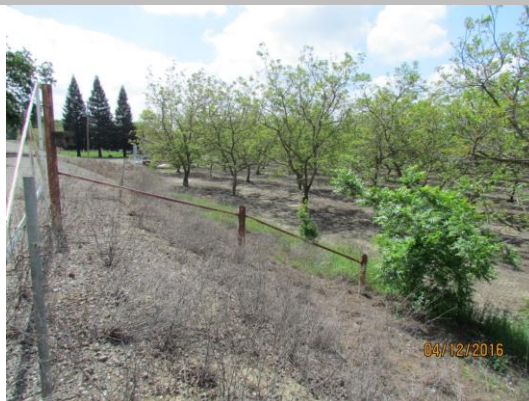
Photo 1 of 1 : SP_2019_NA0022_350_112_20190304_00052.jpg

LM Start	1.77	Rating **	M	Issue No.	112
LM End	1.77	Issue Type +	Ma	Location *	LS
Category	Earthen Levee			GPS Latitude/Longitude	
				Start	End
Item	Vegetation			38.797596 °	38.797596 °
				-121.697855 °	-121.697855 °
DWR ID	DWR_NA0022_01_s_2016_112				
Comment Code					
V2 : Remove the wild growth other than native grasses from the levee slopes.					
Inspector Comment					
Remove walnut and oak trees at landside toe that are less than 4" in diameter at chest height.

View of the tree at the toe of the levee on the landward side looking downstream. Spring 2016.

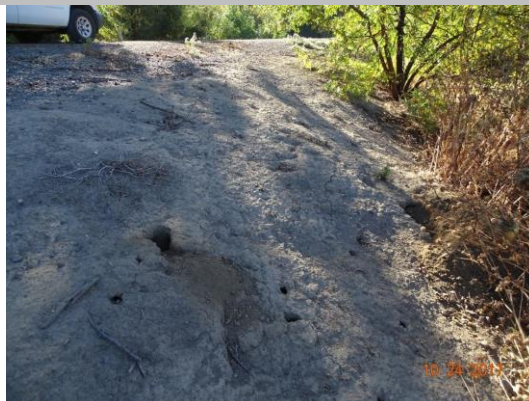
Photo 1 of 2 : SP_2019_NA0022_350_119_20190304_00055.jpg

LM Start	1.96	Rating **	M	Issue No.	119
LM End	1.96	Issue Type +	Ma	Location *	LS
Category	Earthen Levee			GPS Latitude/Longitude	
				Start	End
Item	Animal Control			38.795418 °	38.795418 °
				-121.695964 °	-121.695964 °
DWR ID	DWR_NA0022_01_s_2016_119				
Comment Code					
A3 : No rodents visible, but rodent burrows visible; need to backfill and compact or grout burrows.					
Inspector Comment					
Multiple rodent holes are located on the landside slope near toe.

View of rodent holes on landside slope. Fall 2017.

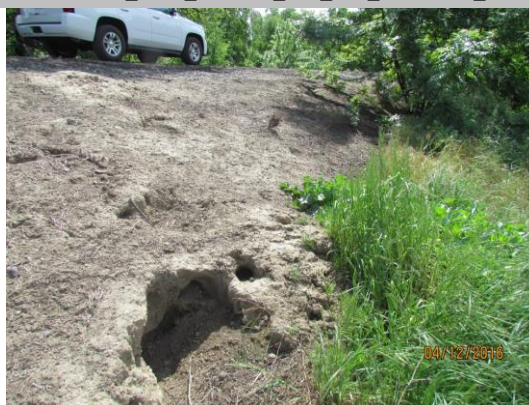
Photo 2 of 2 : SP_2019_NA0022_350_119_20190304_00056.jpg

View of the rodent hole on the landward side of the levee. Spring 2016.

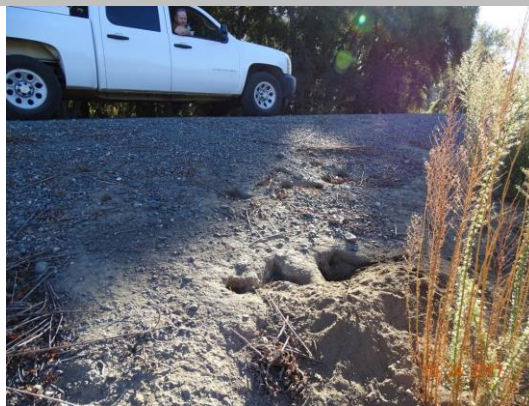
Photo 1 of 2 : SP_2019_NA0022_350_117_20190304_00053.jpg

View of rodent holes on landside slope. Fall 2017.

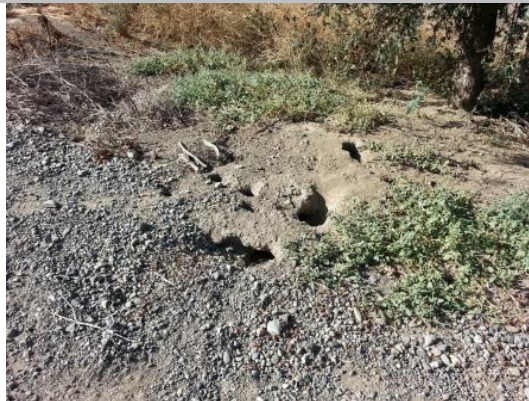
Photo 2 of 2 : SP_2019_NA0022_350_117_20190304_00054.jpg

Series of animal burrows on LS slope of the levee. Fall inspection 10/07/2016.

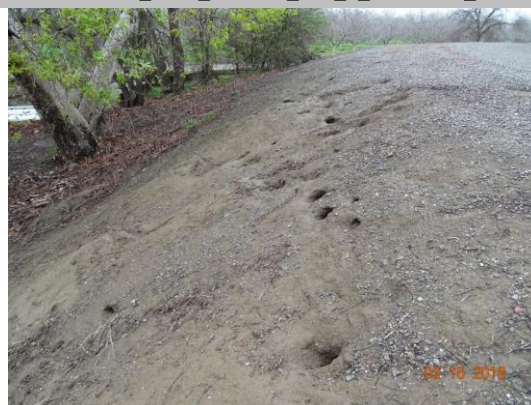
Photo 1 of 2 : SP_2019_NA0022_350_8_20190304_00003.jpg

View of rodent holes on the landside slope. Spring 2018.

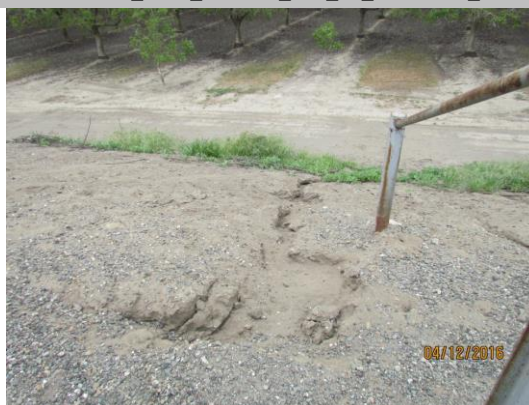
Photo 1 of 2 : SP_2019_NA0022_350_35_20190304_00015.jpg

LM Start	2.24	Rating **	M	Issue No.	35
LM End	2.28	Issue Type +	Ma	Location *	LS
Category	Earthen Levee			GPS Latitude/Longitude	
				Start	End
Item	Erosion / Bank Caving			38.791652 °	38.791172 °
				-121.695403 °	-121.695165 °
DWR ID	DWR_NA0022_01_s_2016_35				
Comment Code					
E2 : Schedule repair of erosion site prior to the next inspection.					
Inspector Comment					
Repair rills on the landward side of the levee.

Erosion is on the landward side of the levee. Spring 2016.

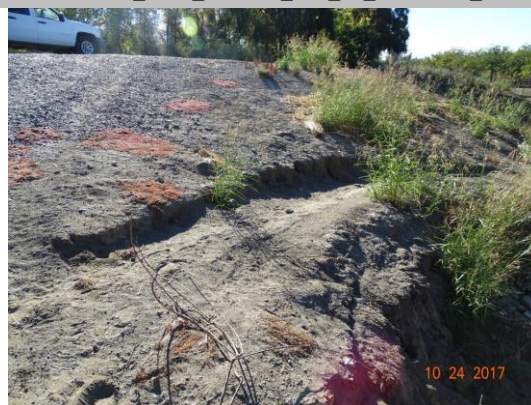
Photo 1 of 4 : SP_2019_NA0022_350_96_20190304_00046.jpg

View of erosion on landside slope. Fall 2017.

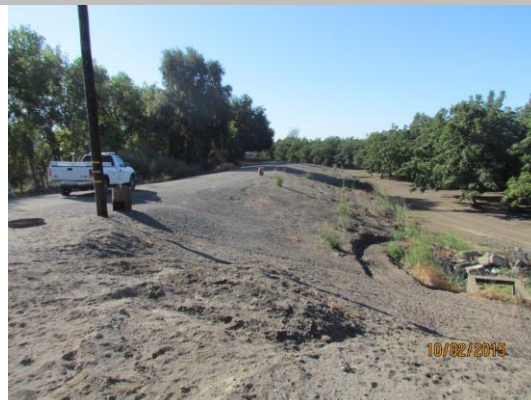
Photo 2 of 4 : SP_2019_NA0022_350_96_20190304_00047.jpg

Perspective view of the erosion around the pipe on the landward side of the levee looking downstream. Fall 2015.

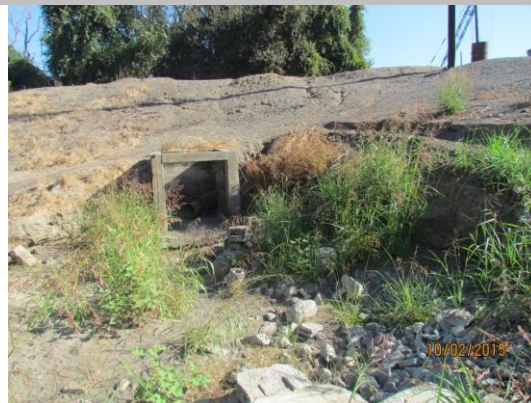
Photo 3 of 4 : SP_2019_NA0022_350_96_20190304_00048.jpg

The erosion is within the levee prism. Fall 2015.

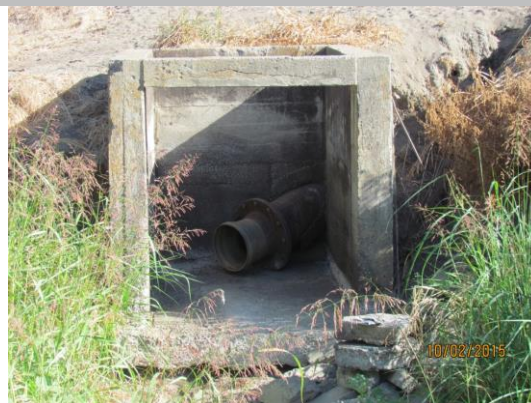
Photo 4 of 4 : SP_2019_NA0022_350_96_20190304_00049.jpg

View of the pipe in the concrete box. Fall 2015.

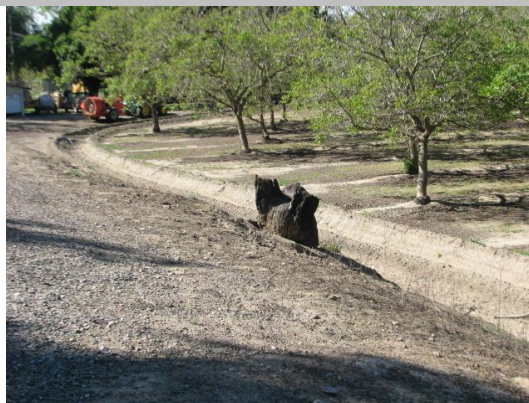
Photo 1 of 1 : SP_2019_NA0022_350_37_20190304_00019.jpg

Tree stump decomposing and may pose a risk to the levee. Spring 2014

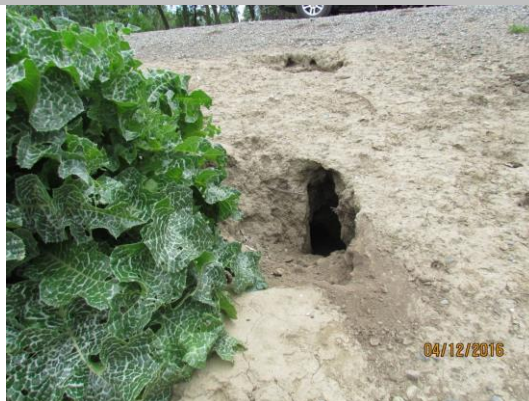
Photo 1 of 2 : SP_2019_NA0022_350_123_20190304_00057.jpg

LM Start	2.52	Rating **	U	Issue No.	123
LM End	2.52	Issue Type +	Ma	Location *	LS
Category	Earthen Levee			GPS Latitude/Longitude	
				Start	End
Item	Animal Control			38.787768 °	38.787768 °
				-121.694295 °	-121.694295 °
DWR ID	DWR_NA0022_01_s_2016_123				
Comment Code					
A3 : No rodents visible, but rodent burrows visible; need to backfill and compact or grout burrows.					
Inspector Comment

View of the rodent hole next to a tree stump on the landward side of the levee. Spring 2016.

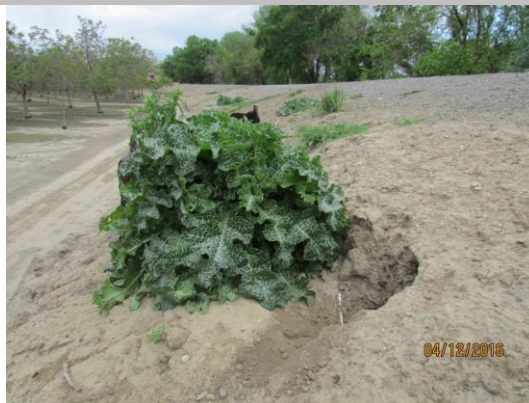
Photo 2 of 2 : SP_2019_NA0022_350_123_20190304_00058.jpg

Perspective view of the rodent hole looking upstream. Spring 2016.

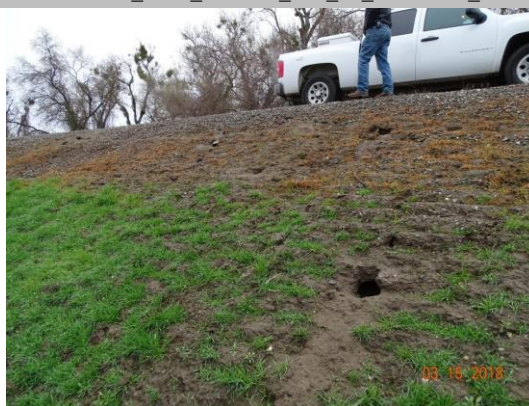
Photo 1 of 1 : SP_2019_NA0022_350_52_20190304_00030.jpg

View of rodent holes on the landside slope. Spring 2018.

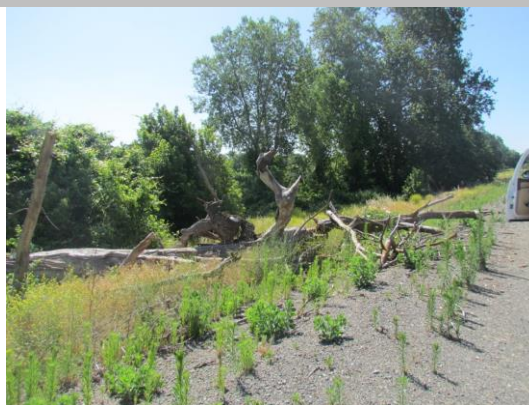
Photo 2 of 2 : SP_2019_NA0022_350_47_20190304_00027.jpg

View of the fallen tree on the waterward side of the levee looking downstream. Spring 2015.

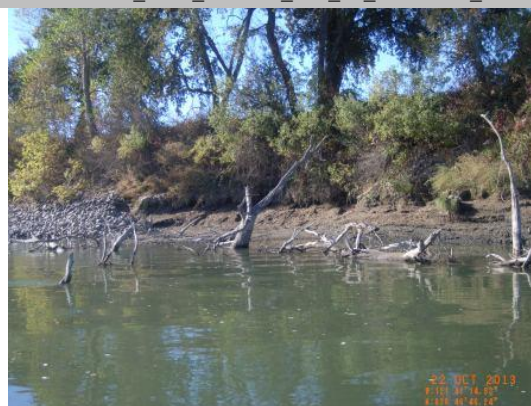
Photo 1 of 1 : SP_2019_NA0022_350_48_20190304_00028.jpg

LM Start	3.18	Rating **	A/W	Issue No.	48
LM End	3.28	Issue Type +	Ma	Location *	WS
Category	Supplemental			GPS Latitude/Longitude	
				Start	End
Item	2017 USACE Erosion Survey, DRAFT			38.780407 °	38.779137 °
				-121.688238 °	-121.687432 °
DWR ID	DWR_NA0022_01_f_2018_48				
Comment Code					
Inspector Comment					
2017 Site ID: SAC 86.9 R					
Status: Eroding					
2017 Field Notes: No observed change.					
Site History: 2006 - Short section is into the levee toe, rest is near the levee toe. Mass failure and fluvial erosion of depositional material. Rock at the upstream and downstream ends. 2011 - Minor new erosion. 2012 - Slope continues to steepen, tree roots have become exposed, and new eddy formed.

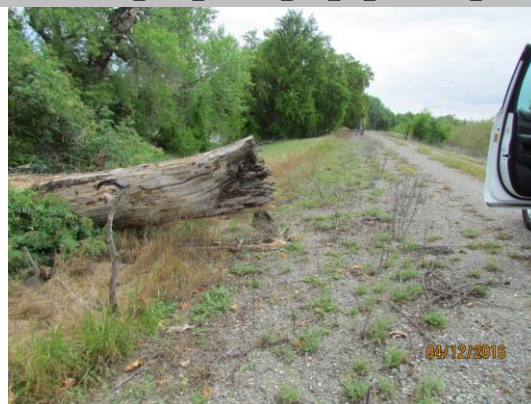
Photo 1 of 1 : SP_2019_NA0022_350_15_20190304_00008.jpg

LM Start	3.20	Rating **	M	Issue No.	15
LM End	3.20	Issue Type +	Ma	Location *	WS
Category	Earthen Levee			GPS Latitude/Longitude	
				Start	End
Item	Encroachments			38.780032°	38.780032°
				-121.688508°	-121.688508°
DWR ID	DWR_NA0022_01_s_2016_15				
Comment Code					
TR : Tree or limb					
Inspector Comment

View of the fallen tree on the waterward slope of the levee looking downstream. Spring 2016.

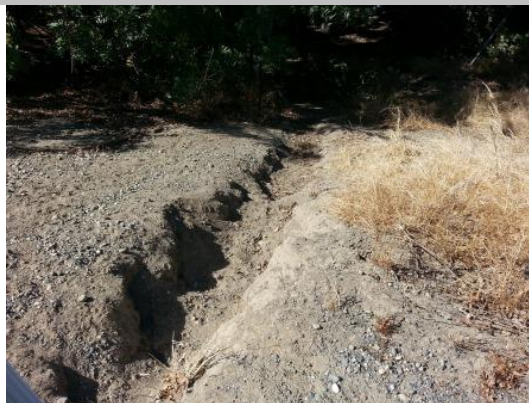
Photo 1 of 3 : SP_2019_NA0022_350_79_20190304_00038.jpg

View of erosion on the landside slope. Fall 2016.

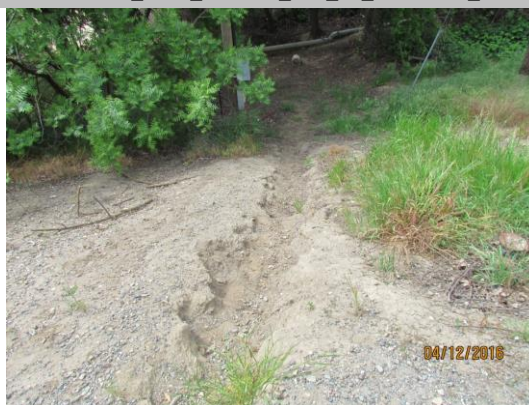
Photo 2 of 3 : SP_2019_NA0022_350_79_20190304_00037.jpg

View of erosion on the landside slope. Spring 2016.

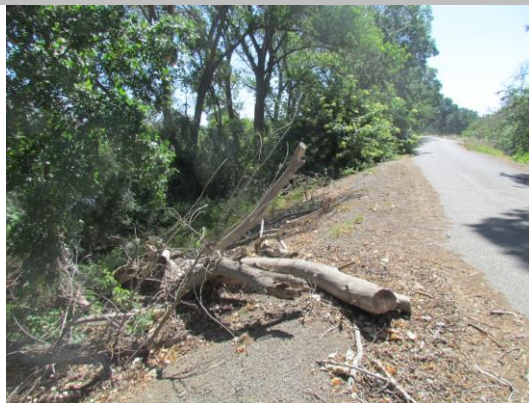
Photo 1 of 1 : SP_2019_NA0022_350_82_20190304_00039.jpg

View of the fallen tree on the waterward side of the levee looking downstream. Spring 2015.

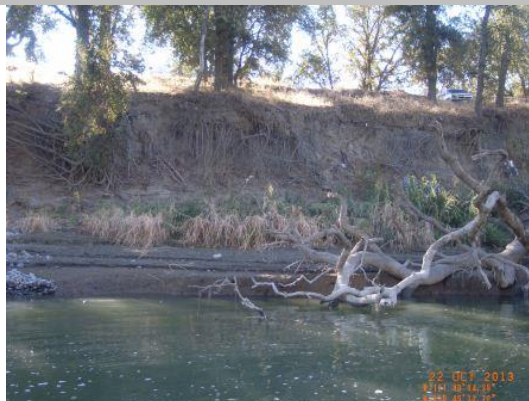
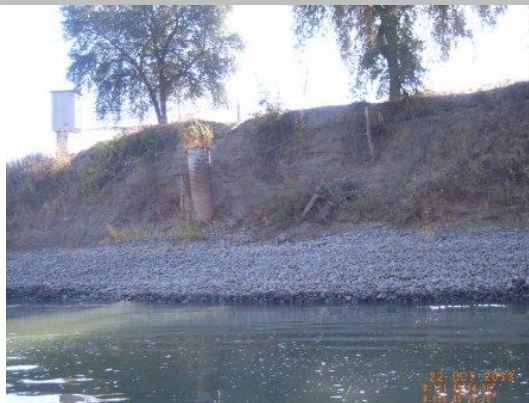
Comment Code					
Inspector Comment					
2017 Site ID: SAC 83.9 R					
Status: Eroding					
2017 Field Notes: Fresh erosion on lower bank.					
Site History: 2006 - Approximately 18 to 20 ft of bank near levee at the corner of the levee and the Freemont Weir. Vertical bank with undercutting/mass failure. 2007 - Staked at top of bank for monitoring.					
2011 - Site has become significantly worse with more of the toe and lower bank eroded. Many trees have fallen since last year. 2012 - Site looks worse with more ersion around trees. 2013 - Additional erosion into the toe. 2015 - Site extended upstream about 500 ft to account for eroding bank. 2016 - Site continues to erode. Multiple trees appear ready to fall into the river.

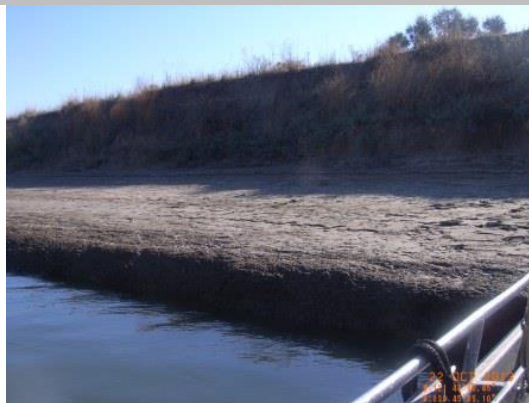
Photo 3 of 3 : SP_2019_NA0022_350_46_20190304_00025.jpg

Comment Code						
Inspector Comment						
2017 Site ID: SAC 83.9 R						
Status: Eroding						
2017 Field Notes: Fresh erosion on lower bank.						
Site History: 2006 - Approximately 18 to 20 ft of bank near levee at the corner of the levee and the Freemont Weir. Vertical bank with undercutting/mass failure. 2007 - Staked at top of bank for monitoring.						
2011 - Site has become significantly worse with more of the toe and lower bank eroded. Many trees have fallen since last year. 2012 - Site looks worse with more ersion around trees. 2013 - Additional erosion into the toe. 2015 - Site extended upstream about 500 ft to account for eroding bank. 2016 - Site continues to erode. Multiple trees appear ready to fall into the river.

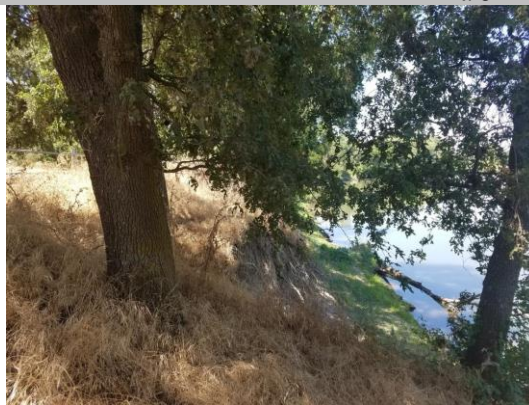
Photo 1 of 1 : LEVAL_SP_2019_490_4925.jpg

LM Start	5.85	Rating **	A/W	Issue No.	57
LM End		Issue Type +	Ma	Location *	
Category	Supplemental			GPS Latitude/Longitude	
				Start	End
Item	2017 Storm Damage			38.759100 °	°
				-121.667964 °	°
DWR ID	DWR_NA0022_01_f_2017_57				
Comment Code					
Inspector Comment					
Levee Evaluation Comments					
Description:Immediately U.S. of Fremont Weir					
Site ID No:490					
Site Designation:LMA-328					
Repair Type: Erosion					
Rating:Serious					
Field Date:7/27/2017					
Notes: wide crown. Erosion not in prism. May be a new erosion pocket, but need to compare to fsrp data. Old veg still present.
